DOT/FAA/AR-95/15

Development of a D SIGHT Aircraft Inspection System: Phase II

March 1996

Final Report

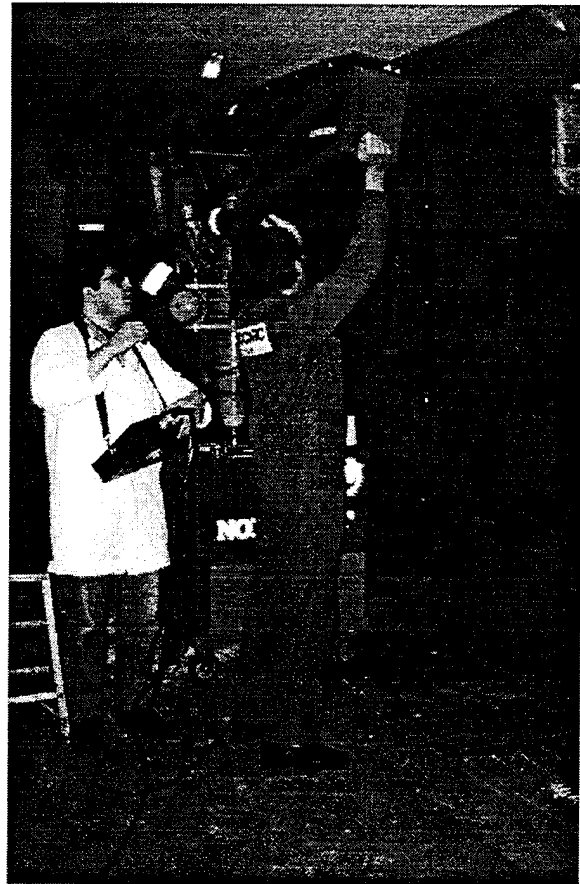
FIGURE 14. INSPECTING B-747 BELLY

The following figures (figures 13 to 21) show the new DAIS equipment being used at various facilities during the field trials. A few typical *D SIGHT* images of the aircraft surfaces are also shown at different corrosion levels (figure 15, figure 20, and figure 21).

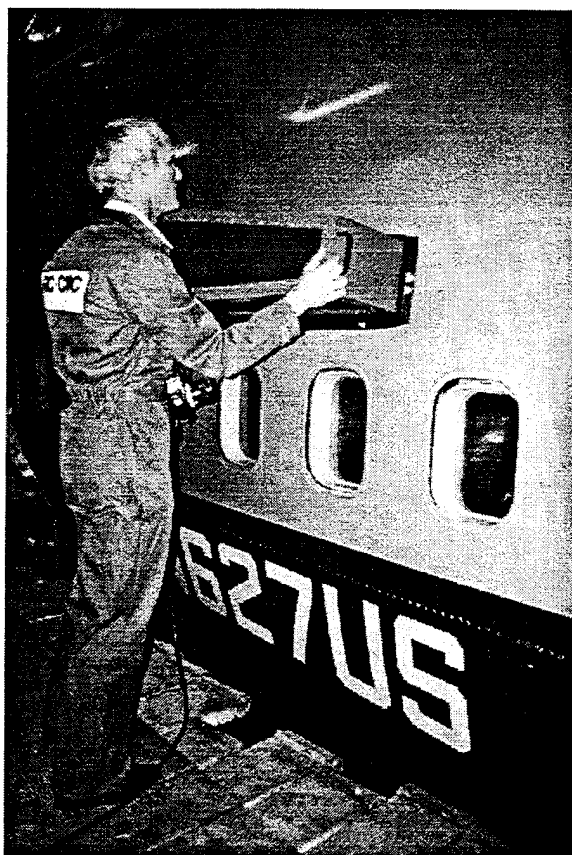
FIGURE 16. INSPECTING UPPER WINDOW BELT

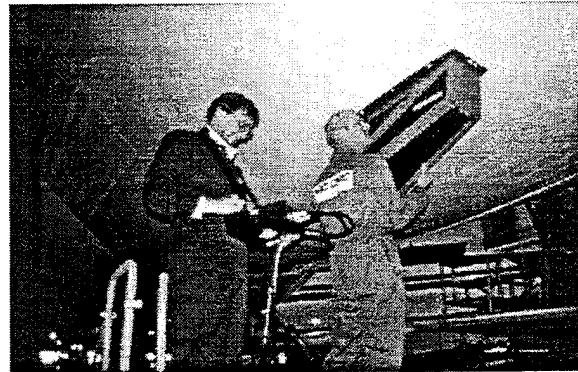
FIGURE 18. B-747 FORWARD BELLY INSPECTION

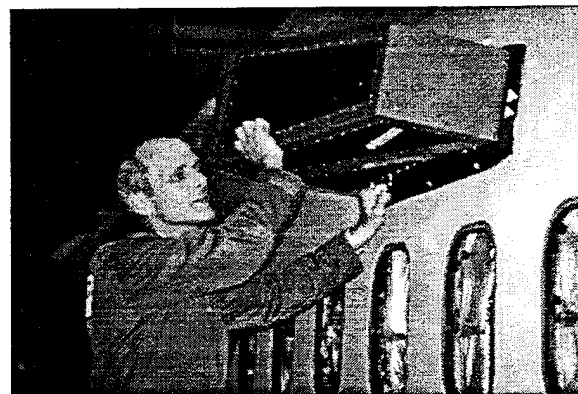
FIGURE 19. UPPER WINDOW BELT INSPECTION
